Impervious Area Assessment

Harford County, MD Department of Public Works
Watershed Protection and Restoration
Watershed Restoration Status (MS4 Permit 11-DP-3310)

Watershed Restoration Project Monitoring - Woodbridge

Woodbridge Year 1 Post-construction Monitoring

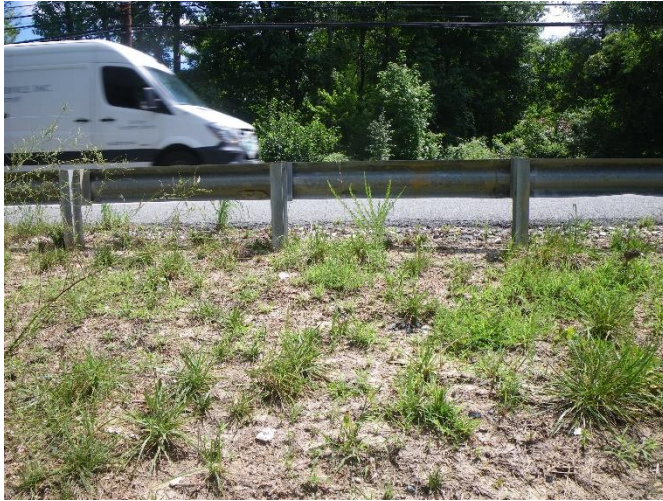
Facing upstream of poor establishment in turf grass zone near road at station 0+00

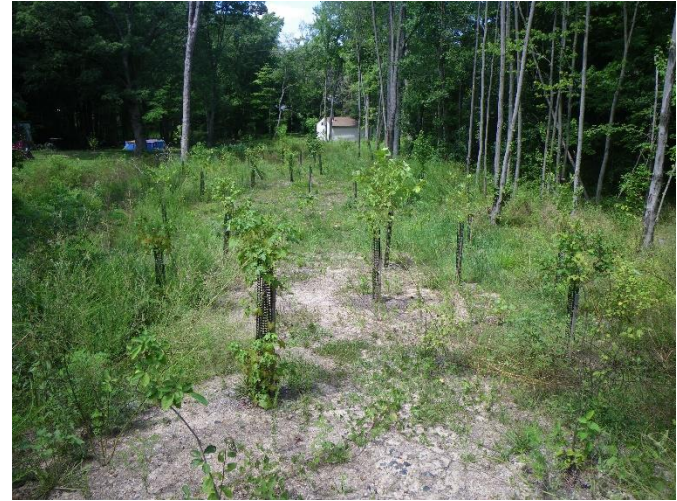
View facing downstream of excellent tree survival and poor herbaceous establishment in riparian zone on right bank from station 0+00

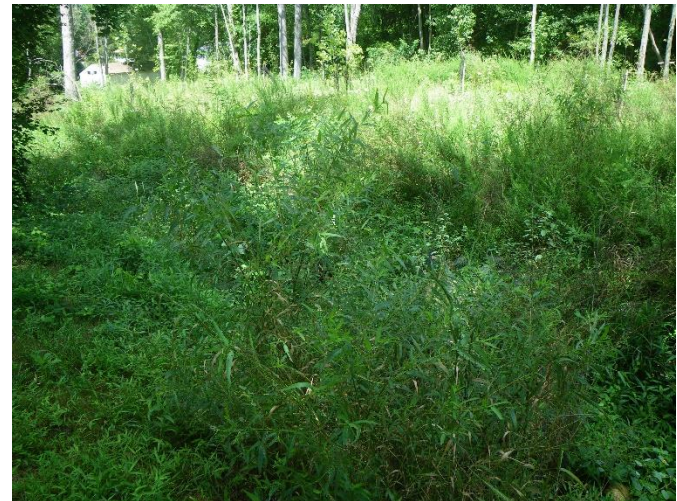
View facing downstream of excellent live stake growth from station 0+25

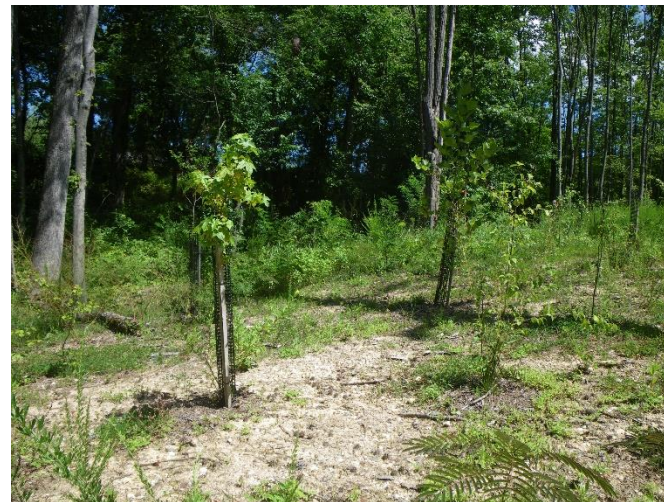
View of poor herbaceous establishment on right bank from station 2+00

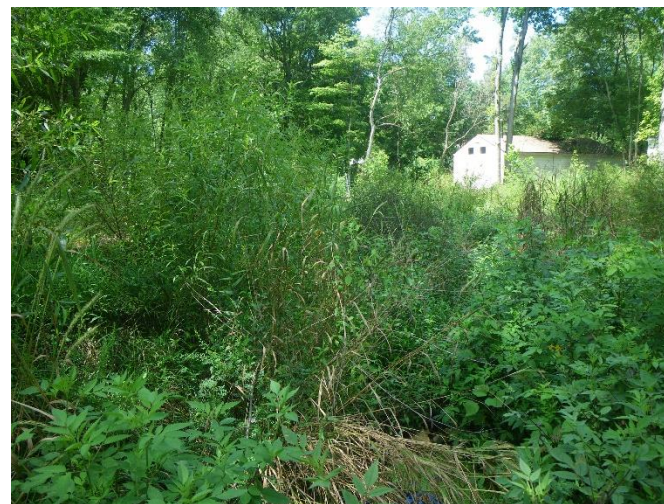
View facing downstream of vigorous live stake growth from station 2+25

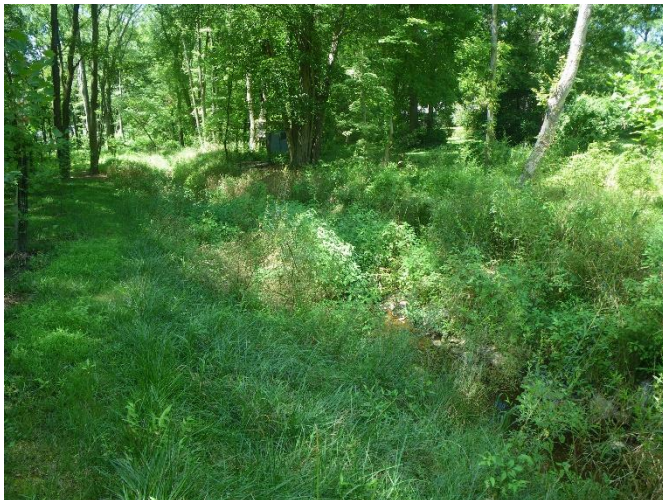
View facing downstream of vigorous live stakes and vegetation in channel from station 2+75

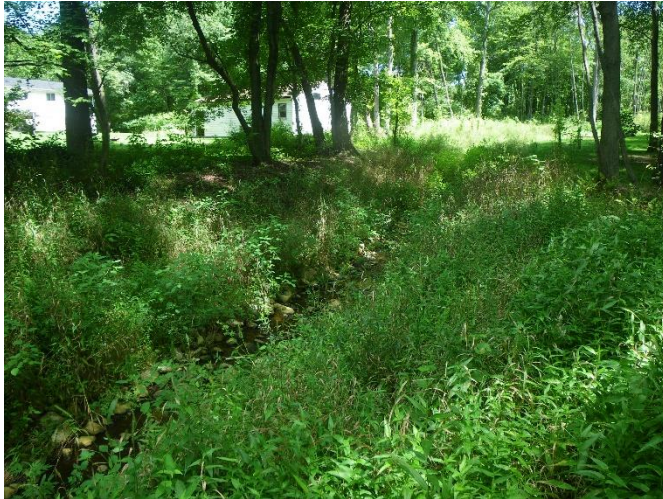
View facing upstream of vigorous herbaceous establishment in riparian zone from station 4+00

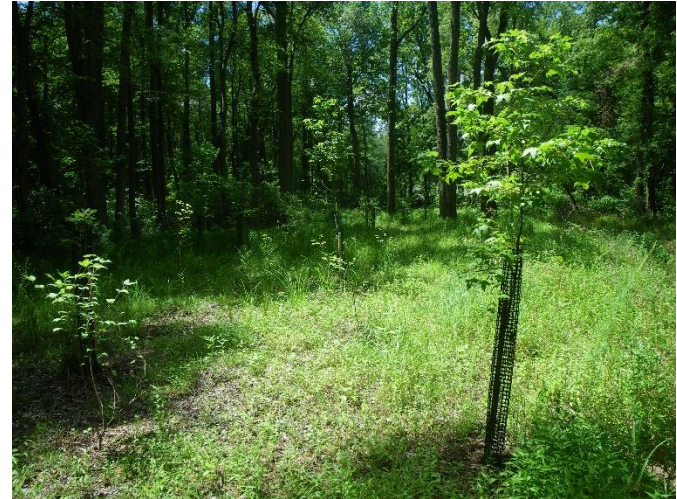
View facing downstream of excellent tree and shrub survival on left bank from station 4+00

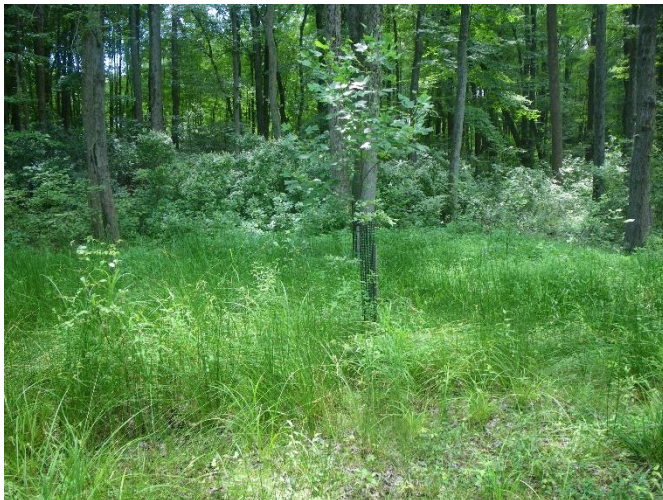
View facing left bank of sedge and rush volunteers in riparian zone from station 4+50

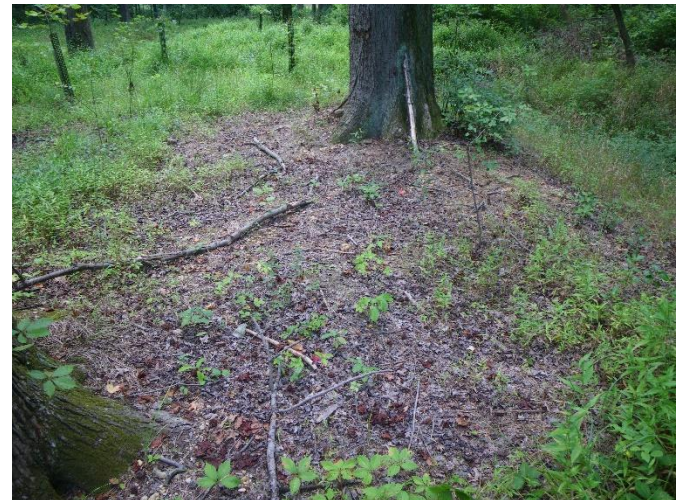
View of bare spot around existing trees on left bank from station 5+25 to 5+50

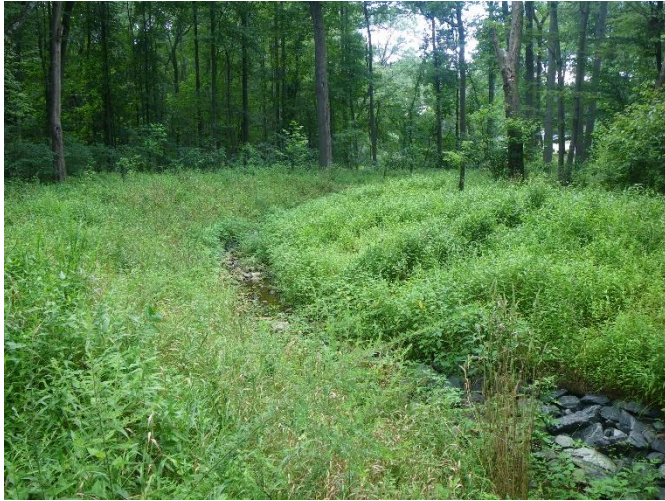
View facing downstream of dense deer tongue grass on right bank from station 5+50

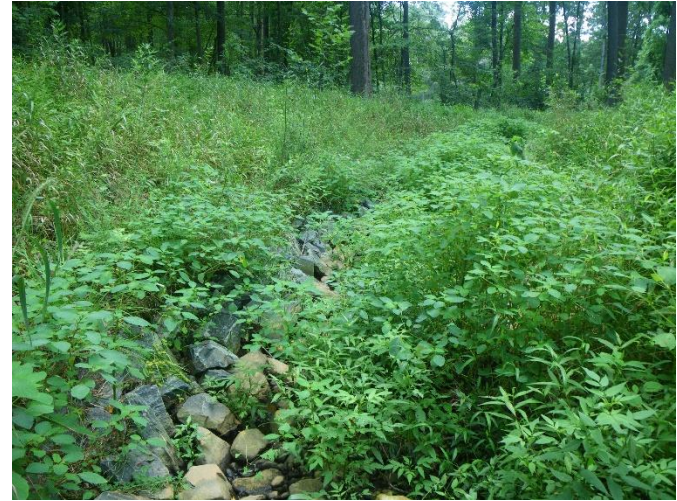
View facing downstream of dense jewelweed in channel from station 6+00

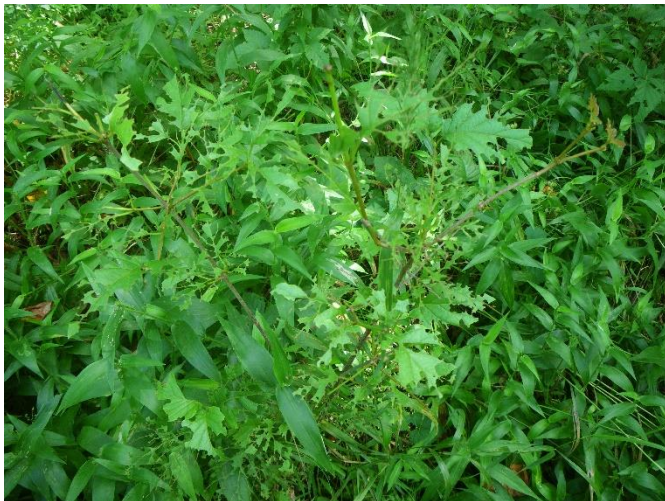
View of skeletonized viburnum leaves, likely from viburnum leaf beetle or Japanese beetle

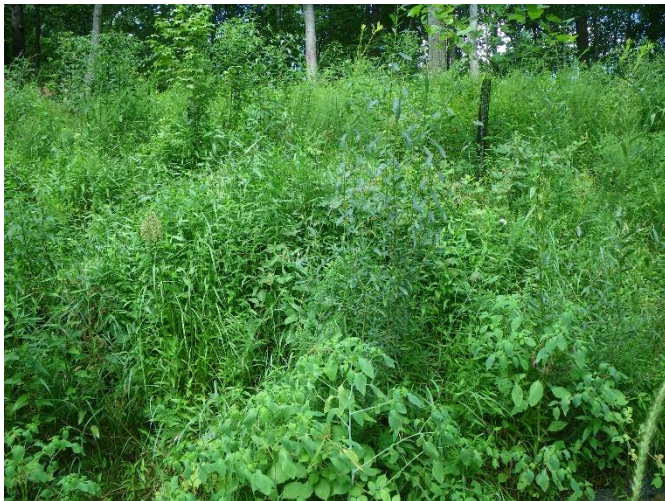
View facing right bank of vigorous willow live stakes from
station 7+75

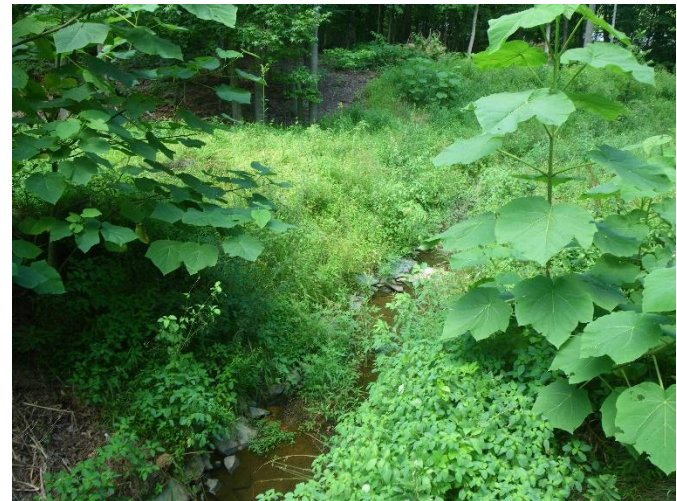
View facing upstream of princess trees at driveway road culvert

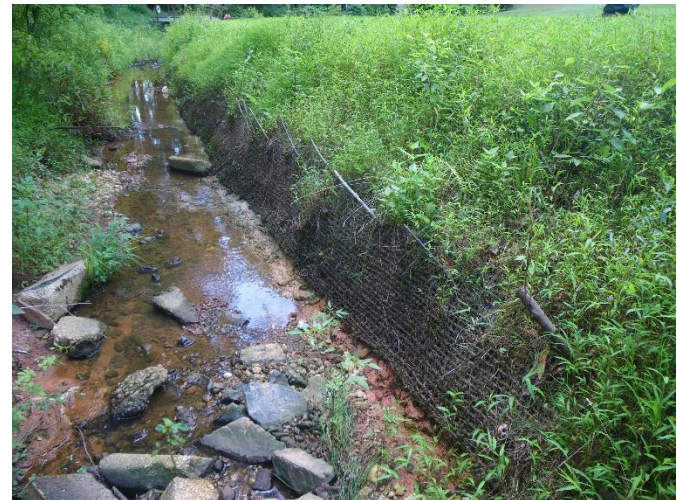
View facing downstream of eroded right bank and dead live
stakes from station 9+50 to 10+00

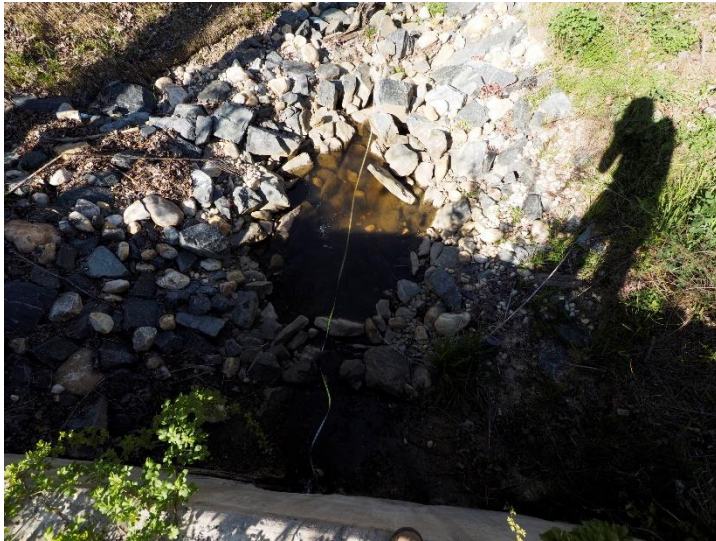
Station 0+00 facing downstream; culvert invert

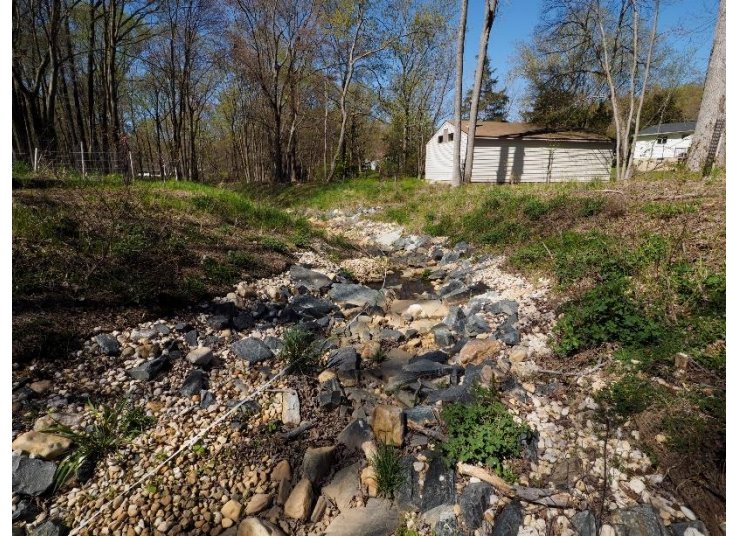
Station 2+25 facing downstream; pool and downstream riffle are dry

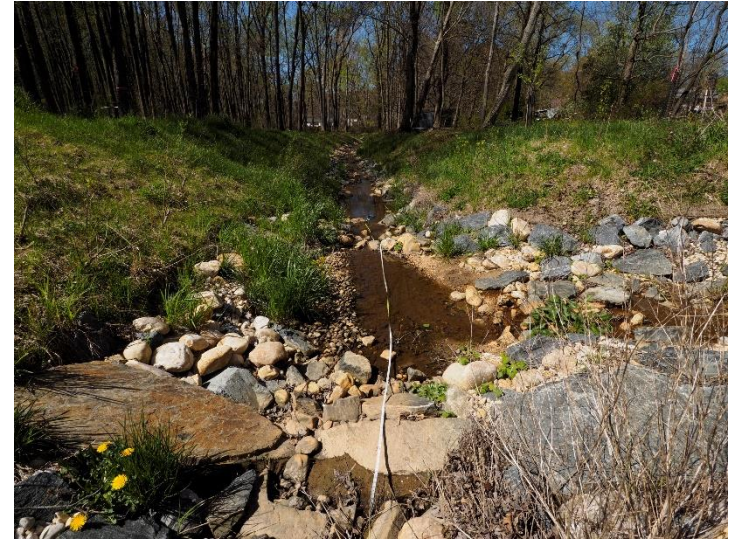
Station 2+87 facing downstream; tributary confluence on right bank

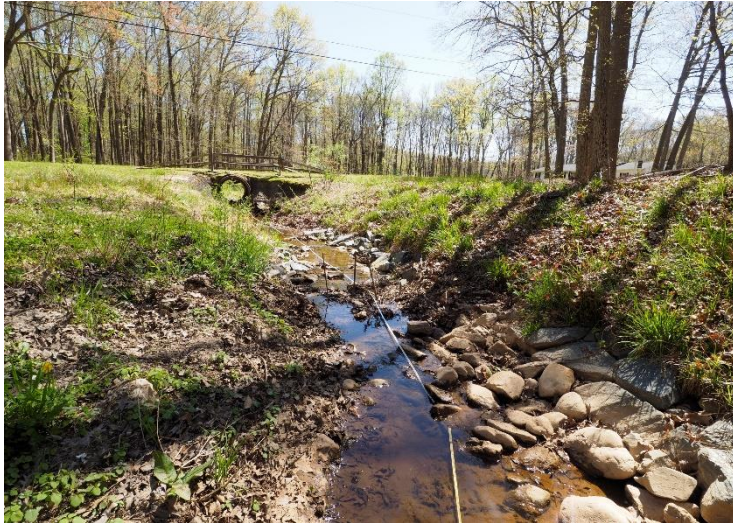
Station 8+25 facing downstream

A series of three step pools were placed from 8+18 to 8+51 with crests at stations 8+18, 8+26, 8+34, 8+42, and 8+51. Each crest was observed to be stable, however, most of the pools were partially or fully filled with fine sediments or leaf litter. This is not anticipated to affect the stability as this material will be easily mobilized during a high flow event when the pools are scoured and needed for energy dissipation.

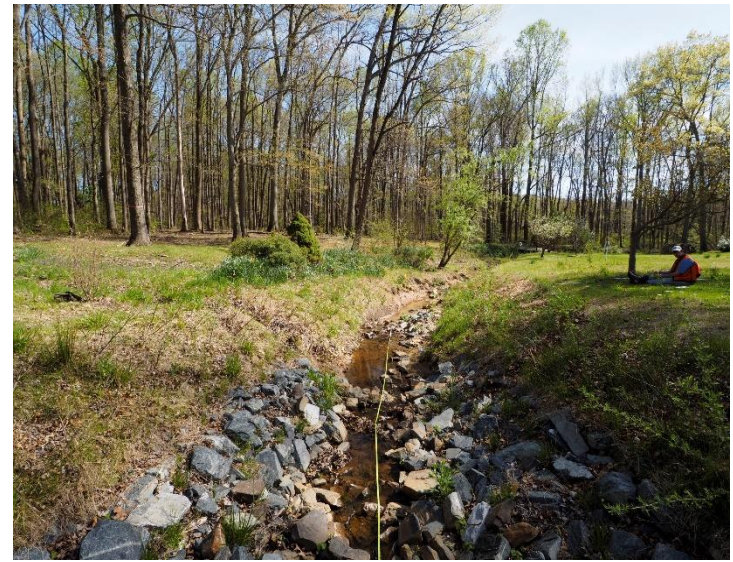
Station 9+00 facing downstream

Stone sills were constructed at stations 9+00 and 12+00. The sill at 9+00 is stable and the scour pool directly downstream is also stable. The sill at 12+00 is located at the downstream extent of the restoration project. This structure is not failing but it is showing some signs of possible instability. This includes the separation of the sill stones, slight tilt to one of the central stones and scour at the downstream side of the sill. Additionally, the weir was installed at grade to the downstream existing bed when constructed, however, a scour hole is now visible for 8 feet downstream of the sill with overall channel downcutting visible. The signs of instability in the sill may be a result of shifting based on stopping the overall channel downcutting that has occurred, which was the purpose of this structure.

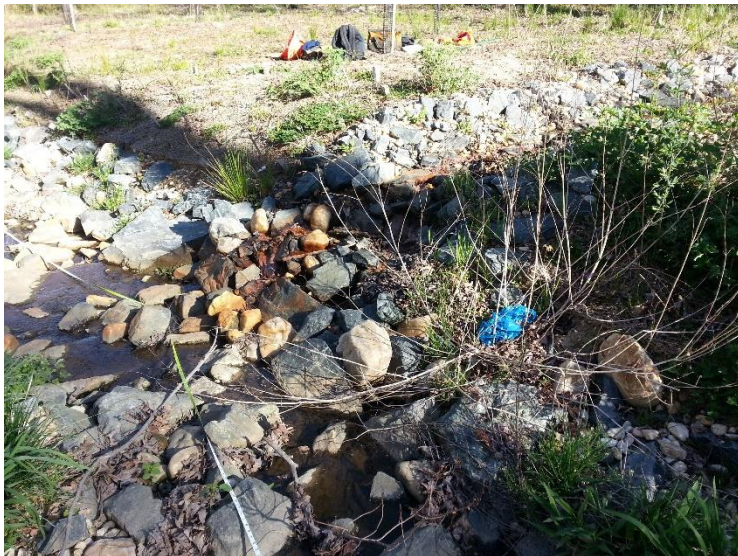
Station 1+75 facing downstream; stepped riffle complex weirs look stable

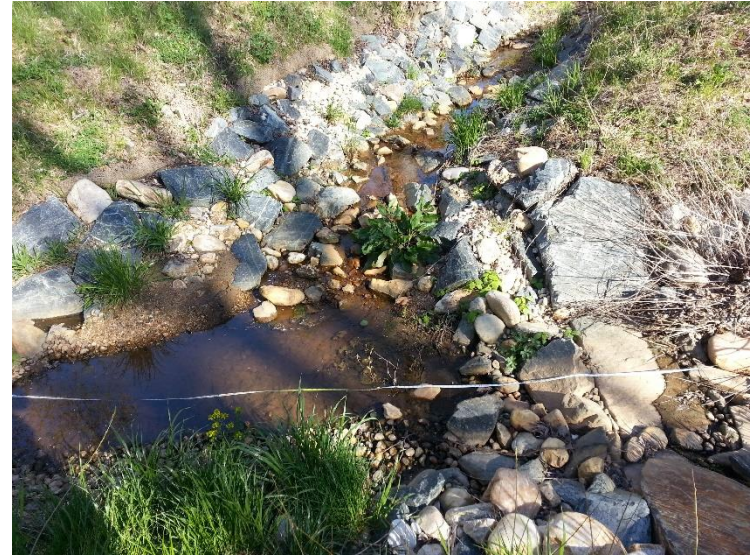
Station 2+87 facing right bank at tributary confluence; tributary tie-in is stable

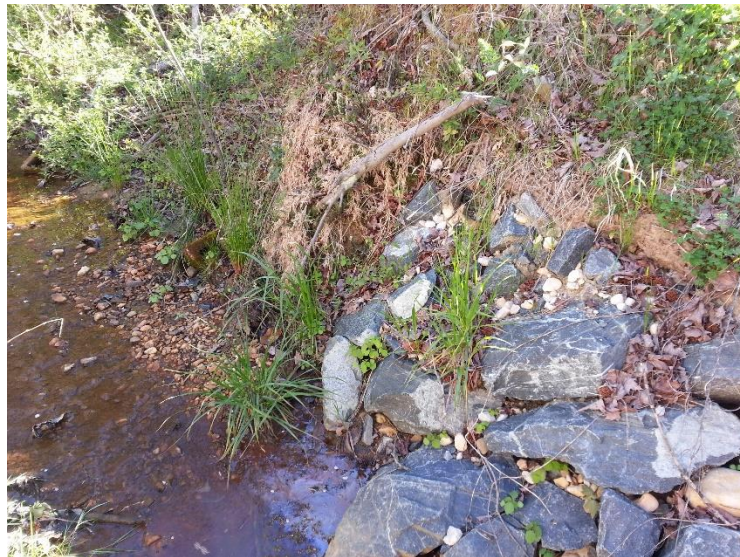
Tributary facing left bank; upstream key-in is stable

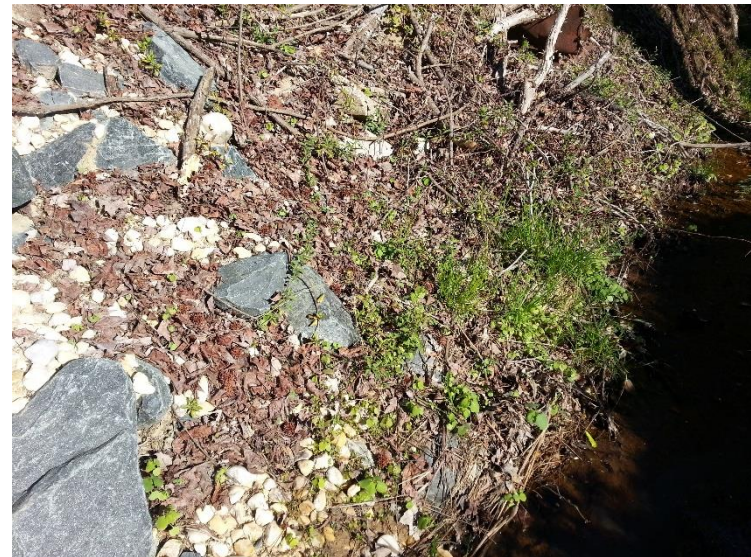
Tributary facing right bank; upstream key-in is stable

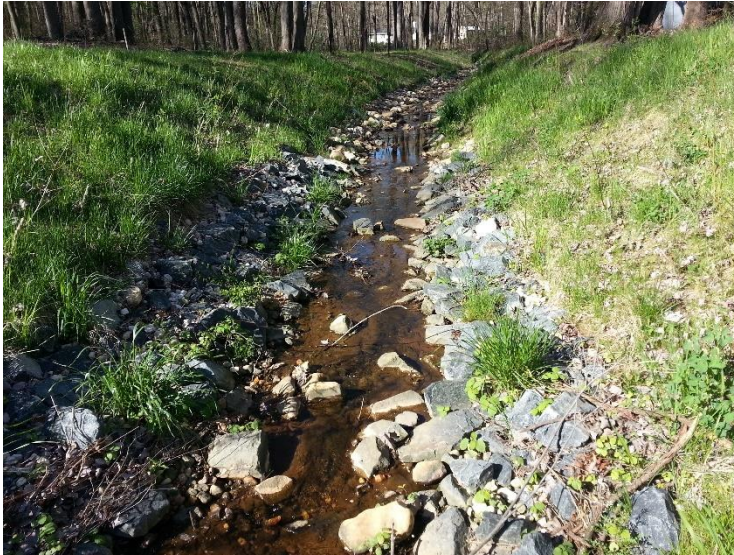
Station 3+20 facing downstream; riffle grade control is stable

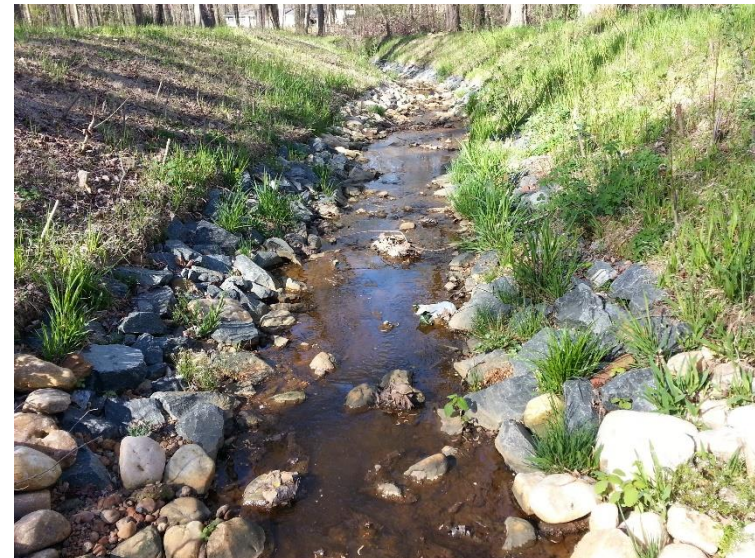
Station 4+25 facing downstream; riffle grade control stable with good side slope correction; no scour at downstream end

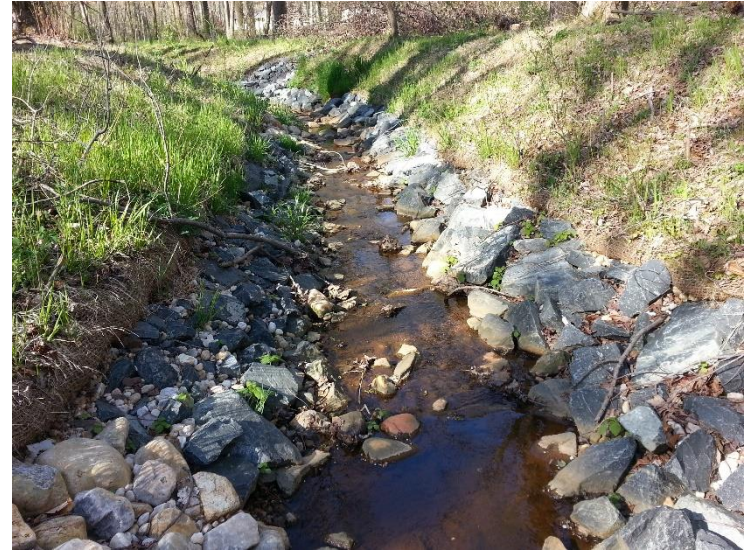
Station 4+95 facing downstream; riffle grade control and stone toe protection stable

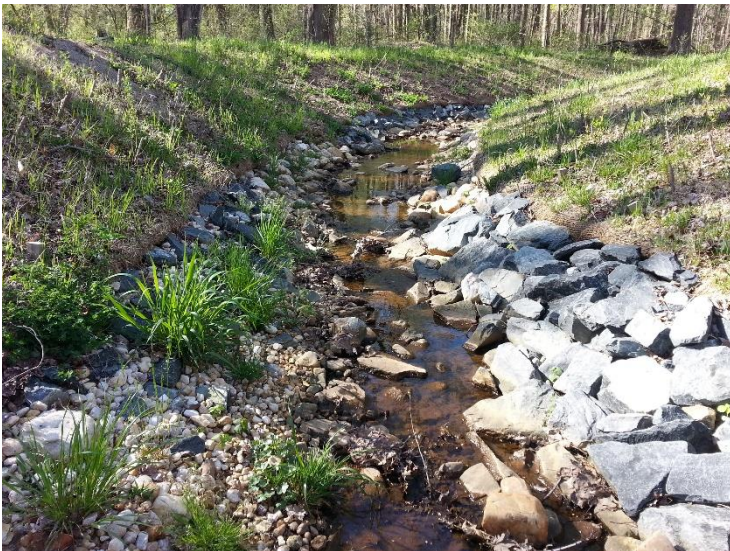
Station 5+50 facing downstream; riffle grade control stable with good blended appearance

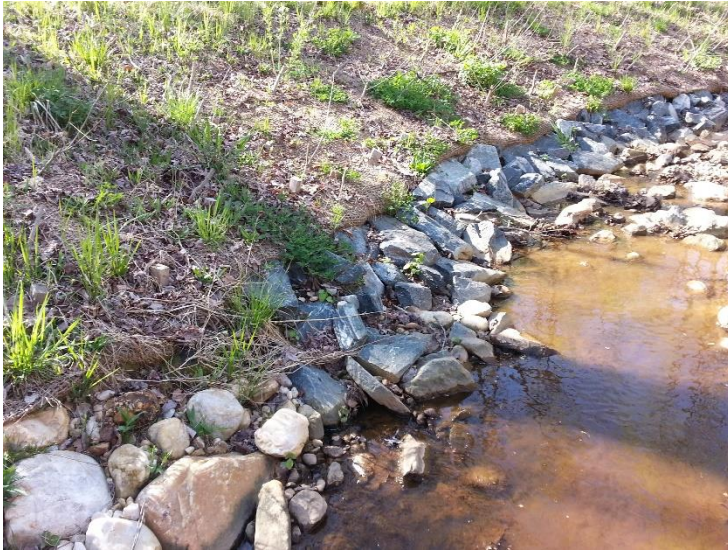
Station 5+90 facing left bank; stable stone toe protection tie-in

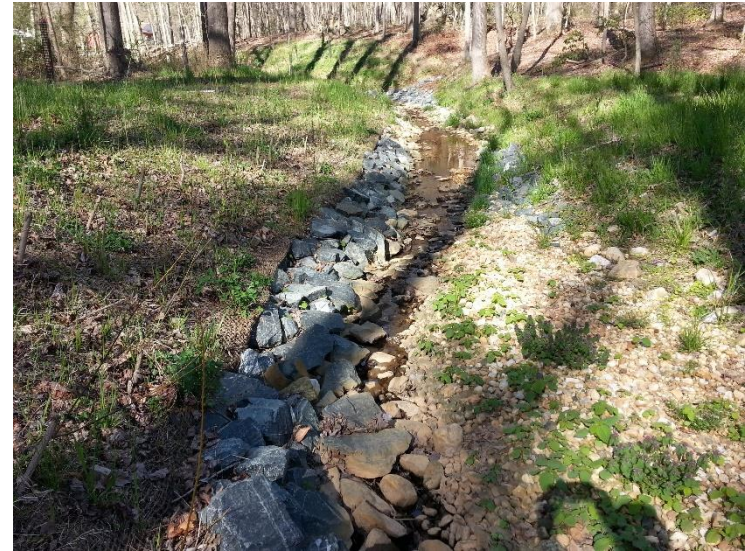
Station 6+30 facing downstream; point bar formation/tailout

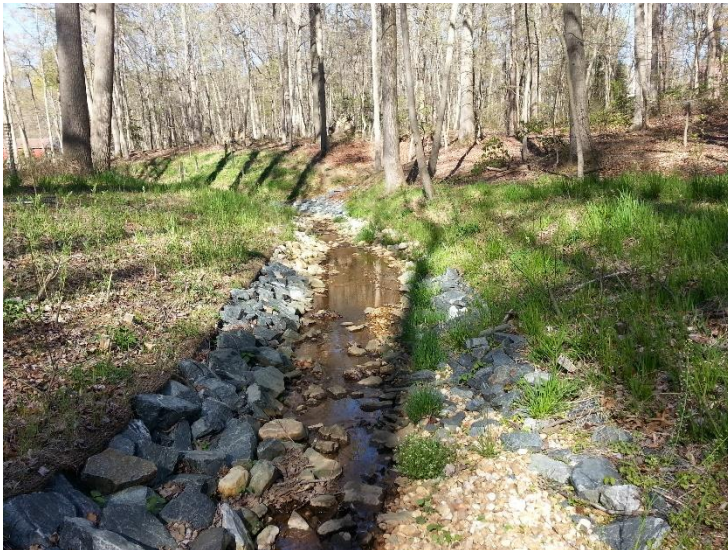
Station 6+50 facing downstream; riffle grade control stable

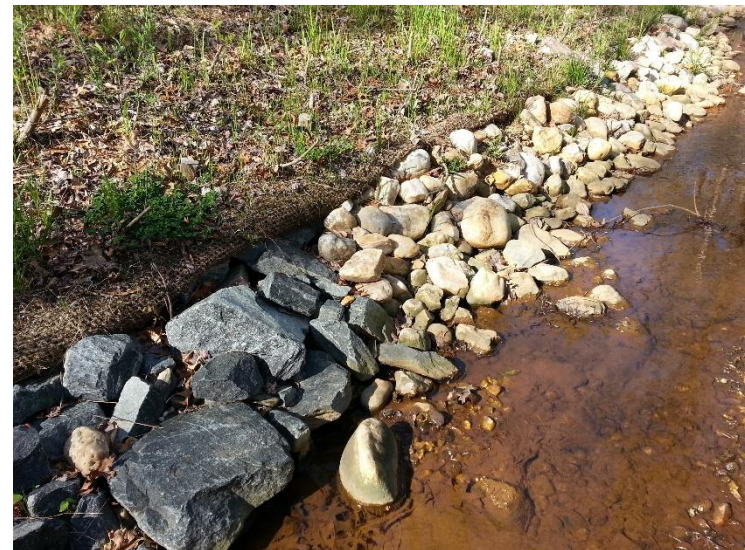
Station 6+90 facing right bank; transition between stone toe protection and channel bed material

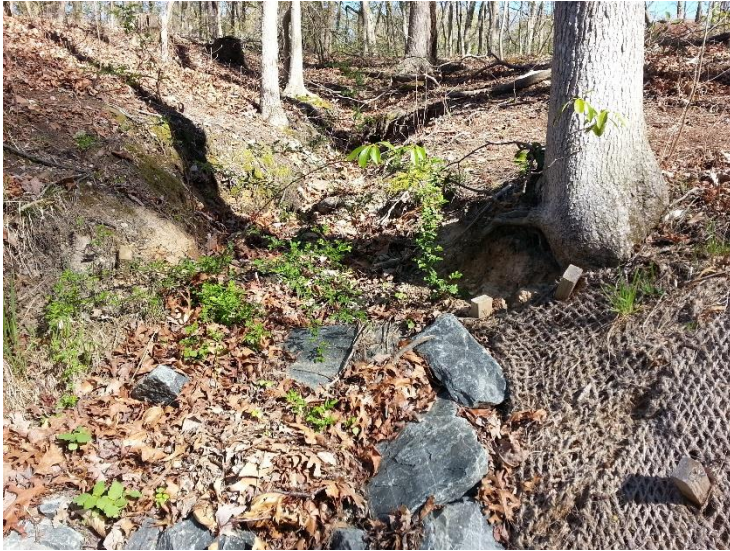
Station 7+51 facing right bank seep channel; tie-in is stable

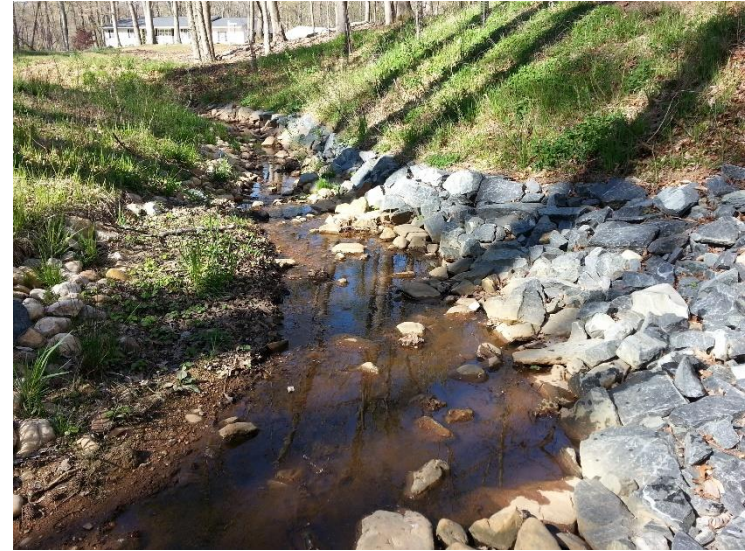
Station 7+51 facing downstream; stone toe protection and seep channel tie-in is stable with some deposition

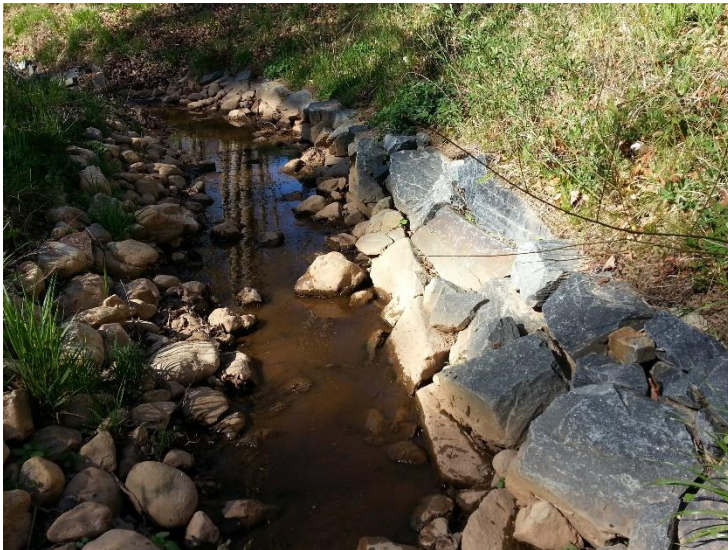
Station 7+90 facing downstream; stone toe protection more "stacked" than laid back, but stable

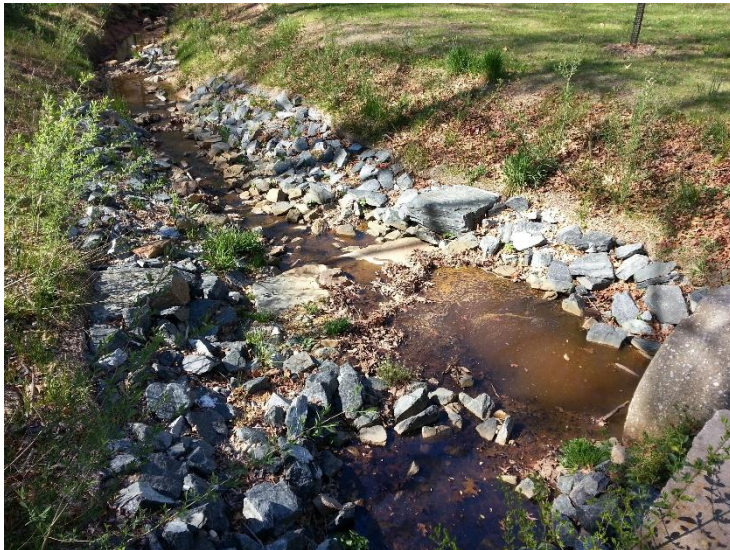
Station 8+85 facing right bank and sill at station 9+00; pool downstream of driveway culvert is stable

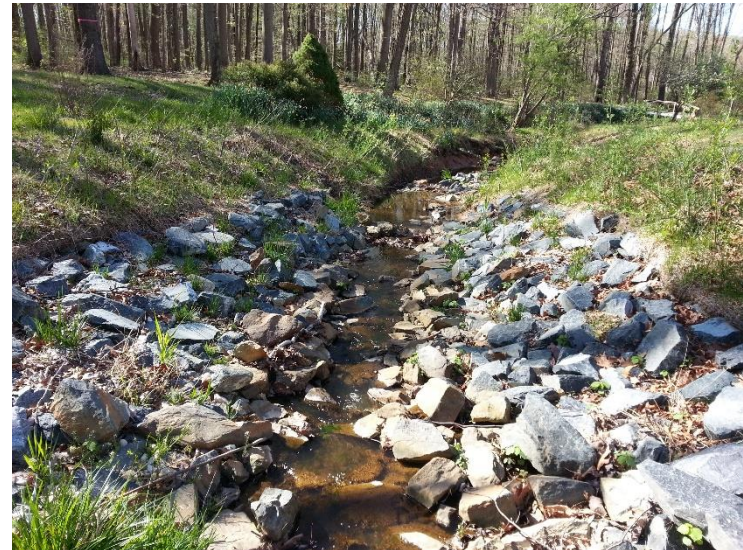
Station 9+00 facing downstream; riffle grade control is stable
